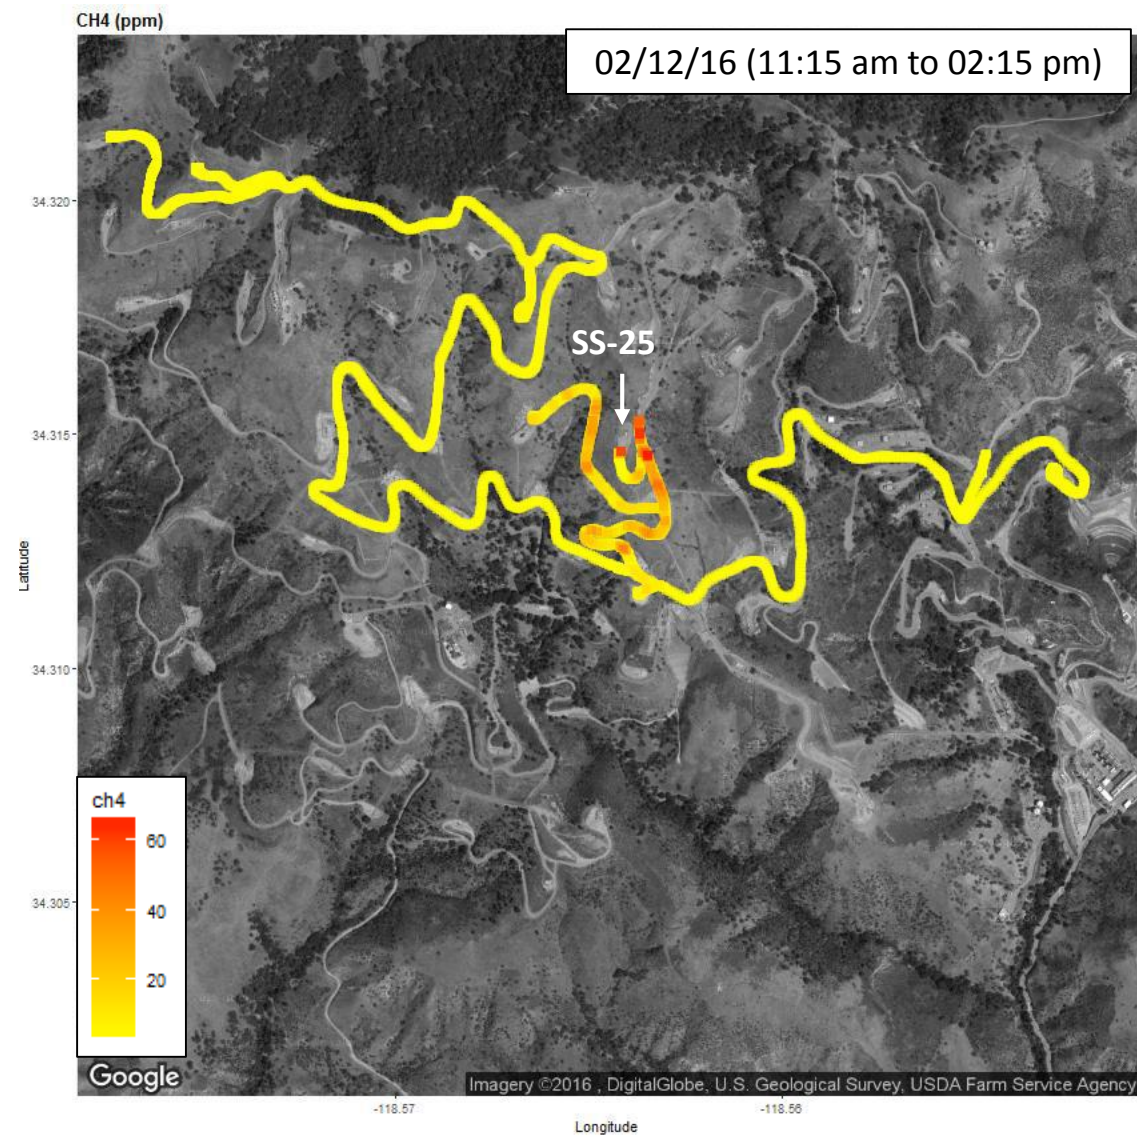
- Increased methane concentrations (up to 38 ppm) were measured ~200 ft NW of SS-25, probably from multiple naturally occurring holes on the side of the hill; SCAQMD inspectors used a portable TVA-1000 monitor to confirm these findings and complement the LICOR data
- SCAQMD staff collected a canister sample at this location
- Two FLIR cameras were also used to identify potential emission sources

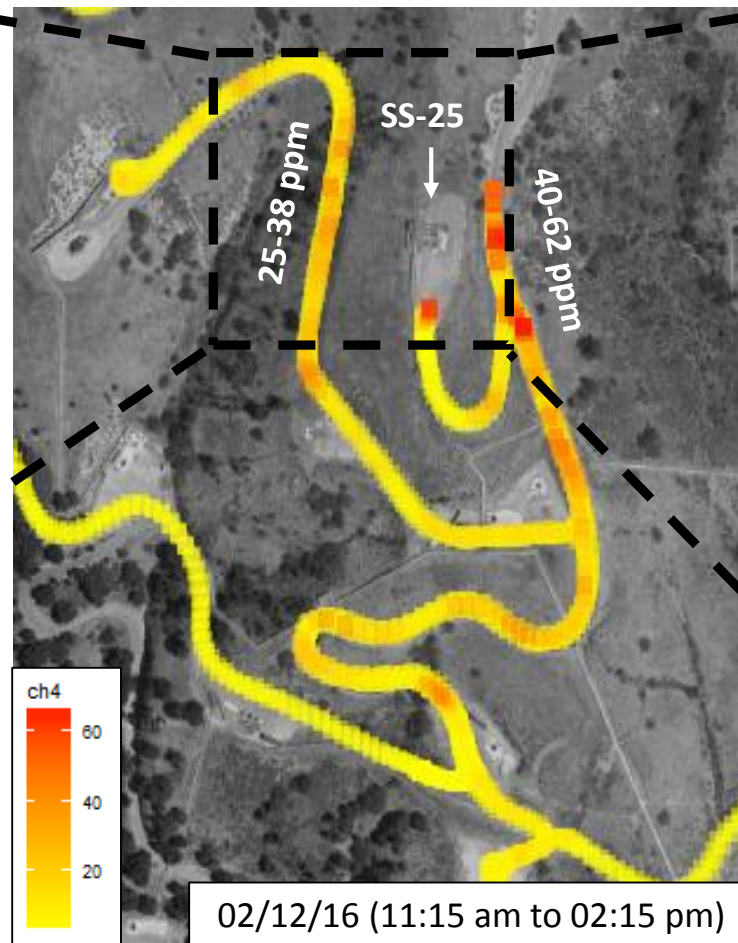
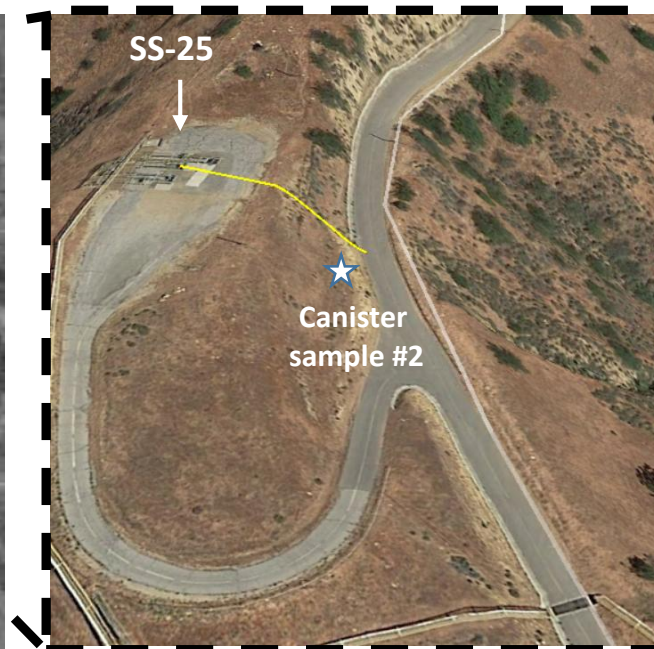
- Elevated methane concentrations (up to 62 ppm) were measured ~150-200 ft E of SS-25, probably from multiple naturally occurring holes on the side of the hill; SCAQMD inspectors used a portable TVA-1000 monitor to confirm these findings and complement the LICOR data; winds and methane concentrations were very variable
- SCAQMD staff collected a second canister sample at this location
- FLIR cameras identified a “weak” emission plume flowing downhill from the SS-25 well; occasionally a smell of mercaptan was detected

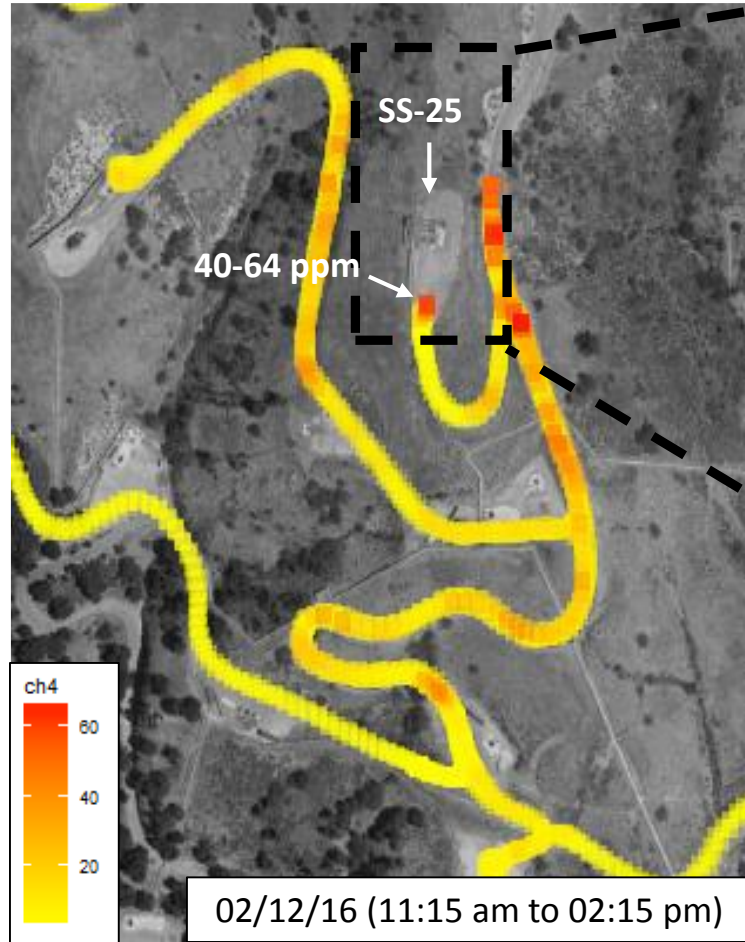
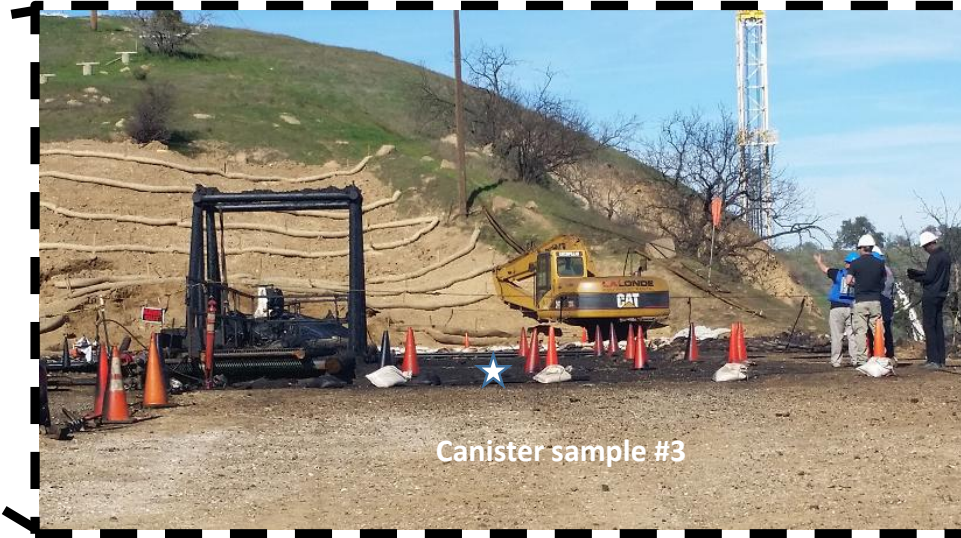
- Elevated methane concentrations (up to 64 ppm) were measured ~80 ft S of the SS-25 well's head; SCAQMD inspectors used a portable TVA-1000 monitor to confirm these findings and complement the LICOR data; winds and methane concentrations were very variable
- SCAQMD staff collected a third canister sample at this location
- FLIR camera videos taken several hundred feet NW of SS-25 by SCAQMD inspectors and SoCalGas staff did not show the presence of a natural gas leak from this well

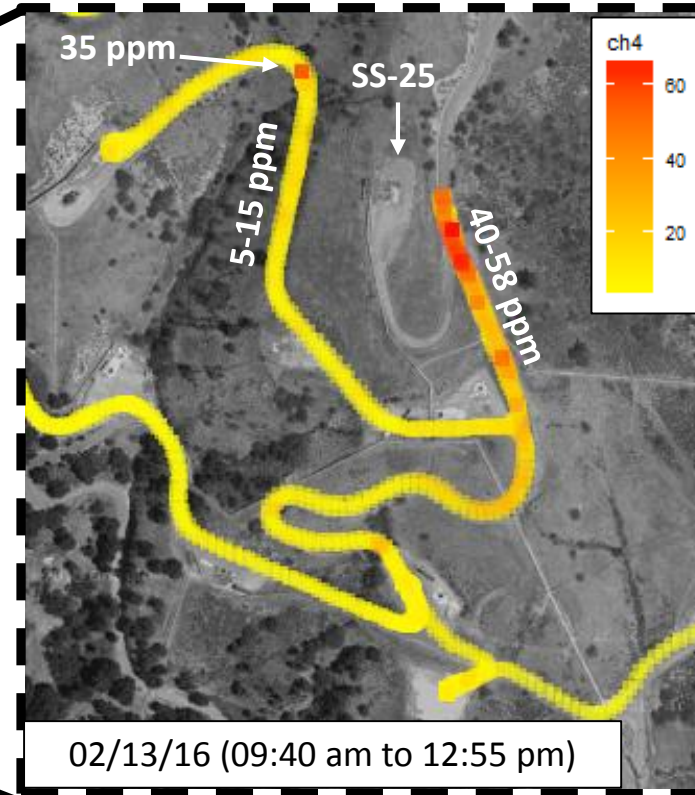
- Elevated methane concentrations (up to 58 ppm) were measured ~150-200 ft E of SS-25, probably from multiple naturally occurring holes on the side of the hill; SCAQMD inspectors used a portable TVA-1000 monitor to confirm these findings and complement the LICOR data; winds and methane concentrations were variable
- Increased methane concentrations (mostly in the 5-15 ppm range) were also measured ~200 ft NW of SS-25
- Videos were taken with FLIR cameras to identify the presence of natural gas
